**NASA Contractor Report 180809**

**EVALUATION OF COATED COLUMBIUM TEST  
PANELS HAVING APPLICATION TO A  
SECONDARY NOZZLE EXTENSION FOR THE  
RL10 ROCKET ENGINE SYSTEM; PARTS I  
AND II**

**FINAL REPORT**

*Pratt & Whitney  
Government Engine Business  
P.O. Box 109600  
West Palm Beach, Florida 33410-9600*

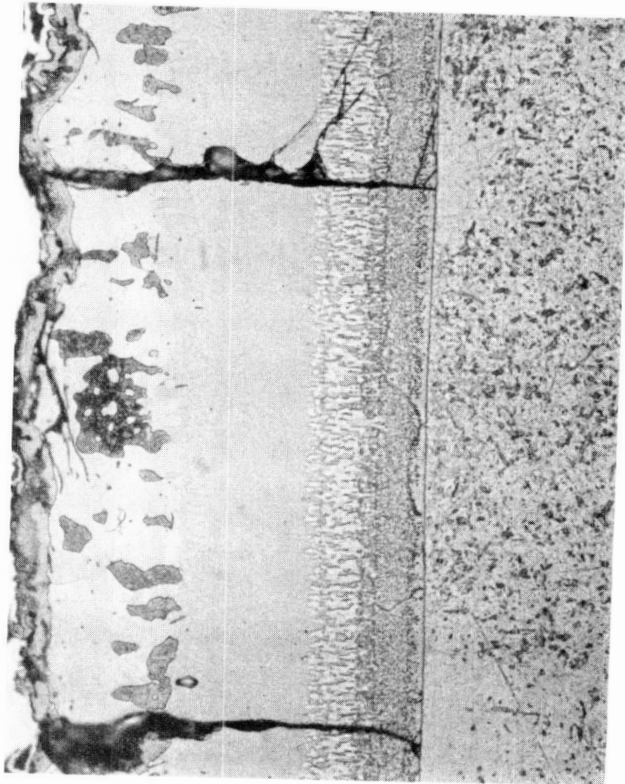
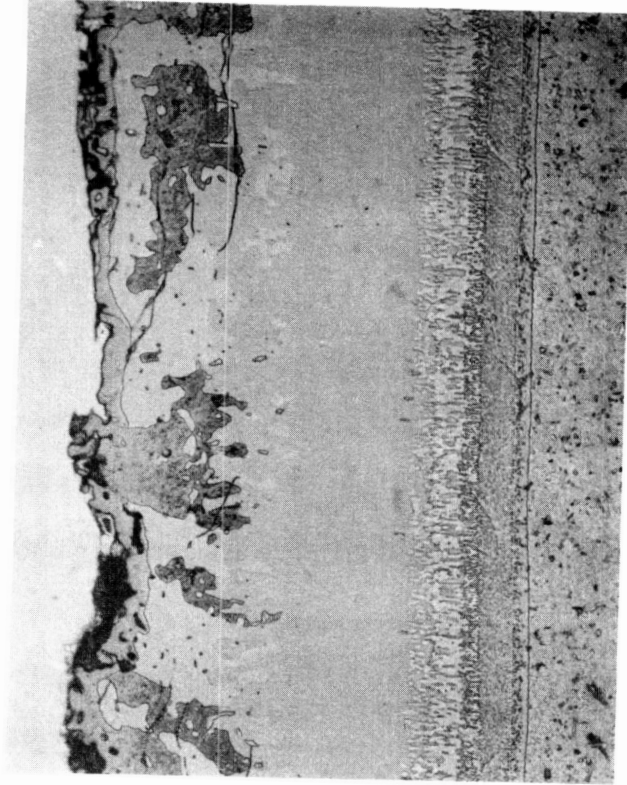
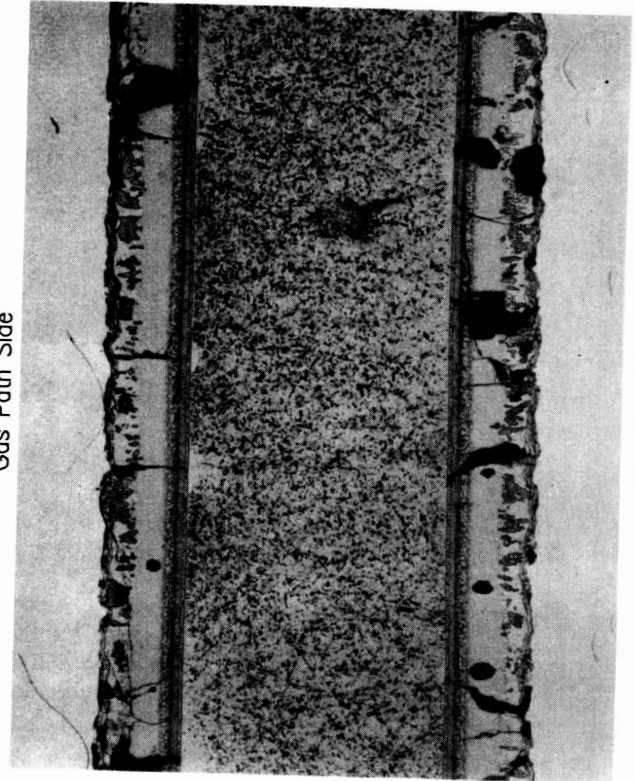
Review of the microstructures, progressing from the inlet plane of the extension to the exit plane of the extension, revealed no significant deleterious features (Figures 3-34 through 3-38). Changes in the original coating microstructure did occur. Thermal exposure allowed additional elemental partitioning. Thus, the composition of coating phases may have been slightly altered during engine exposure.

Figure 3-36. R512-E Coating Microstructure at Region 4 (S/N 60317-4) — Run Time: 4451 seconds — Start/Stop Cycles: 23

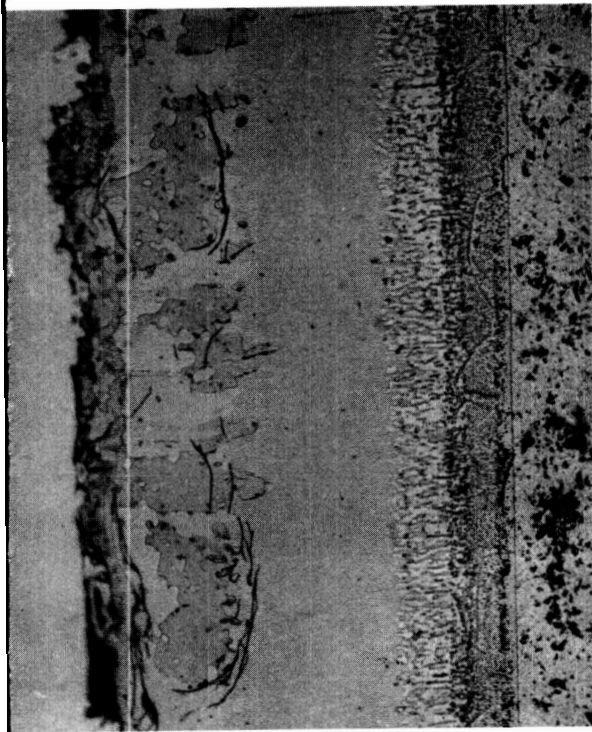
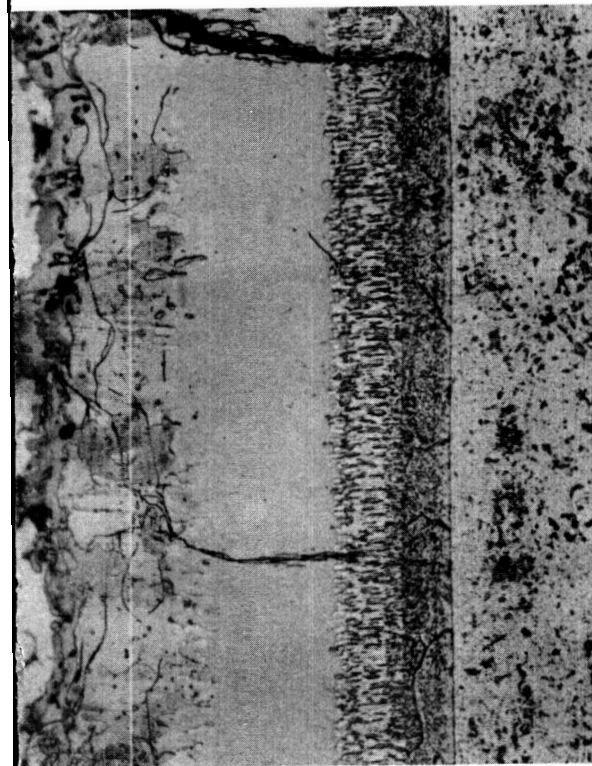
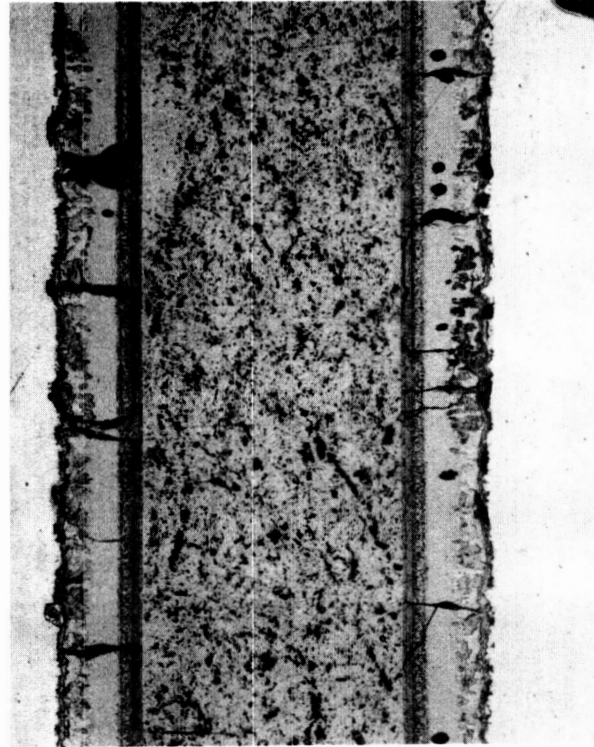
Figure 3-37. R512-E Coating Microstructure at Region 5 (S/N 60317-5) — Run Time:  
4451 seconds — Start/Stop Cycles: 23

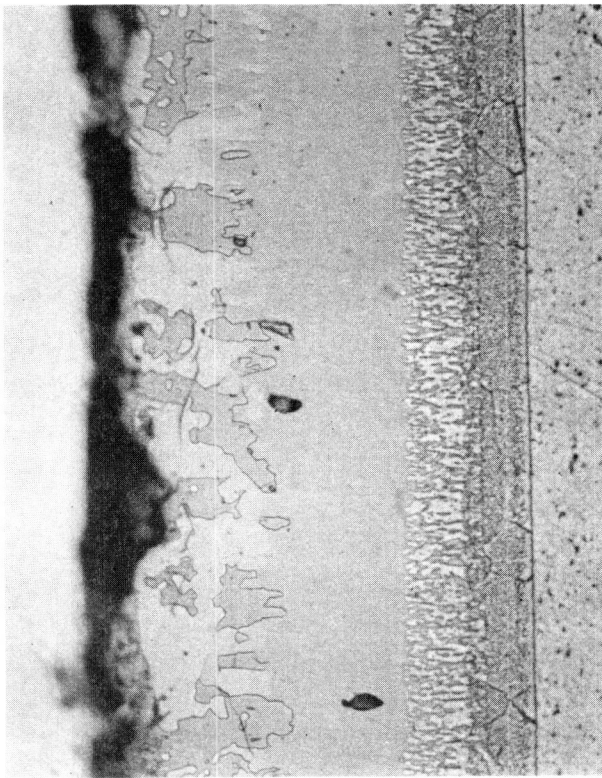
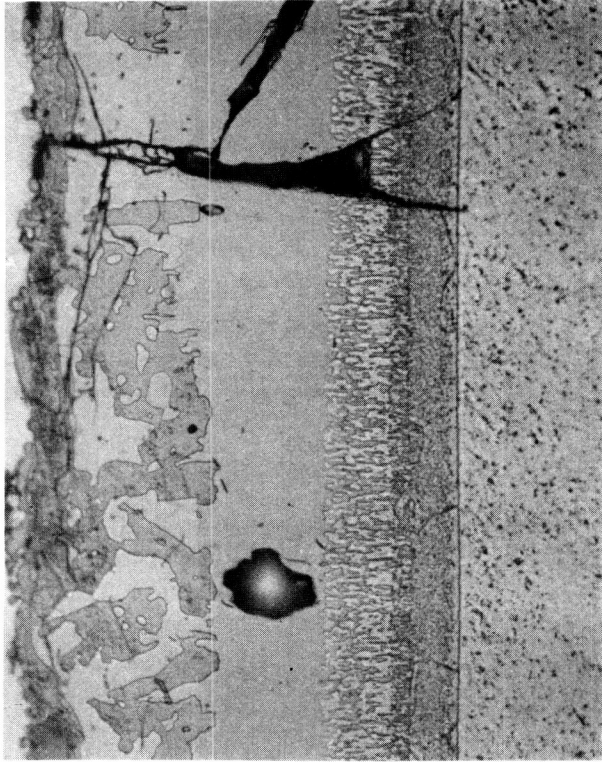
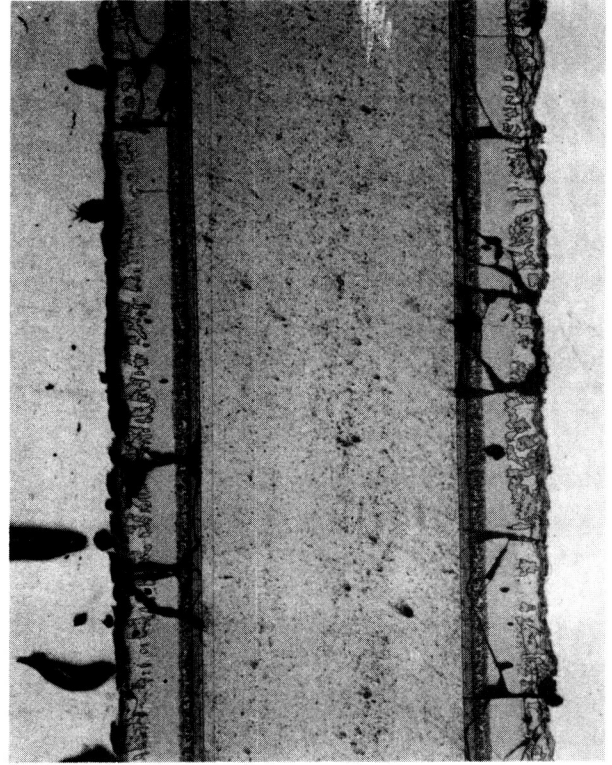
Figure 3-38. R512-E Coating Microstructure at Region 6 (S/N 60317-6) — Run Time: 4451 seconds — Start/Stop Cycles: 23

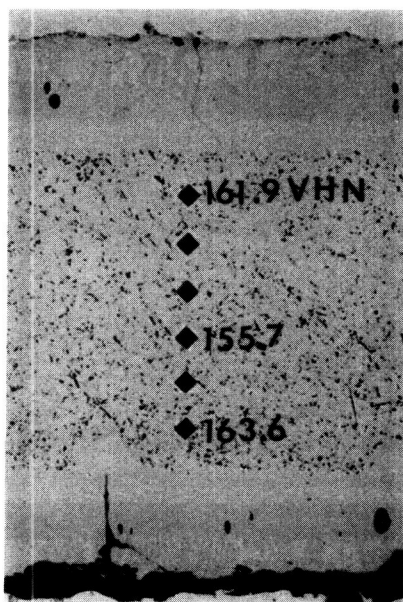
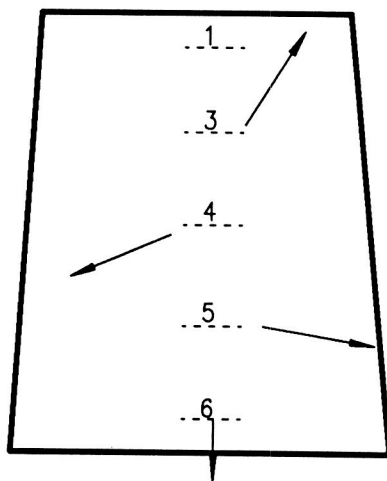
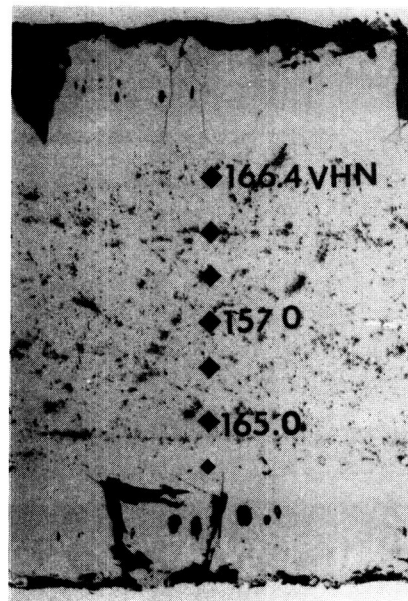
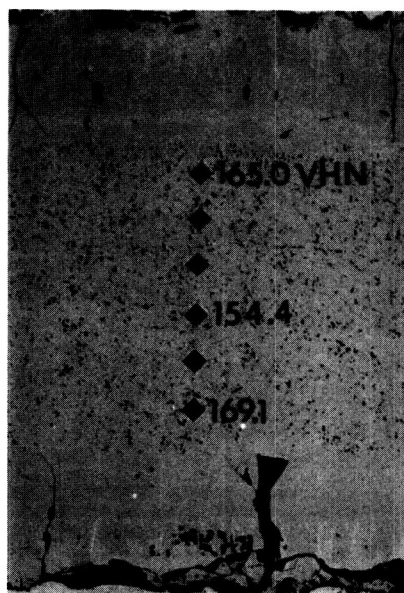
Figure 3-39. Microhardness Measurements Through the Thickness of R512-E Coated C-103 Test Panel — Run Time: 4451 seconds — Start/Stop Cycles: 23

The C-103 substrate appears to have been protected from the embrittling effects of  $H_2$  and  $O_2$  gases. No significant change in microhardness from virgin C-103 was detected (Figure 3-39). The values ranged from 155 VHN to 170 VHN as compared with the 160 VHN for virgin C-103. One location in Region 3 (260VHN) and one location in Region 5 (unlabeled) were higher than expected; but, again, the measurements appear to have been affected by coating/substrate alloy effects.

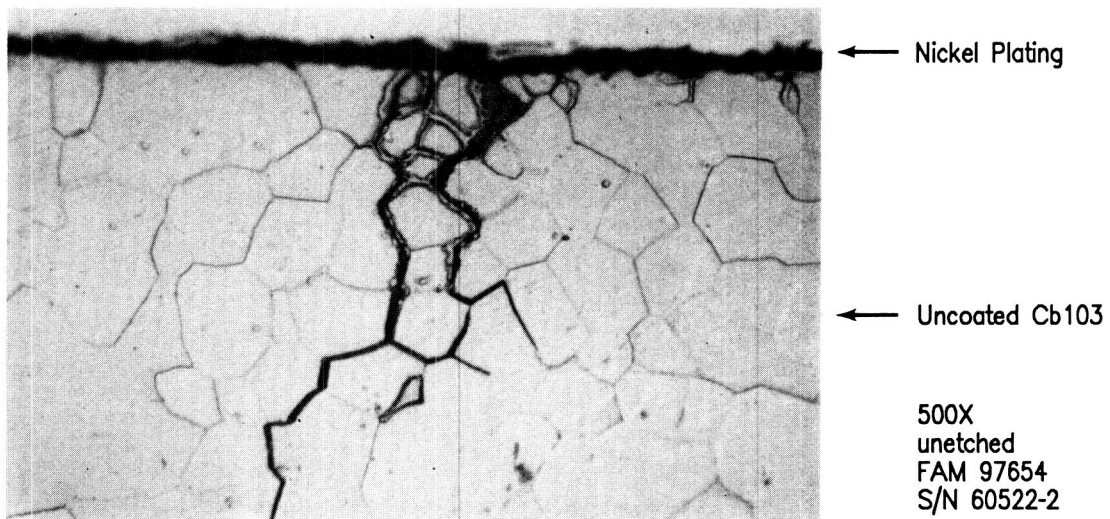
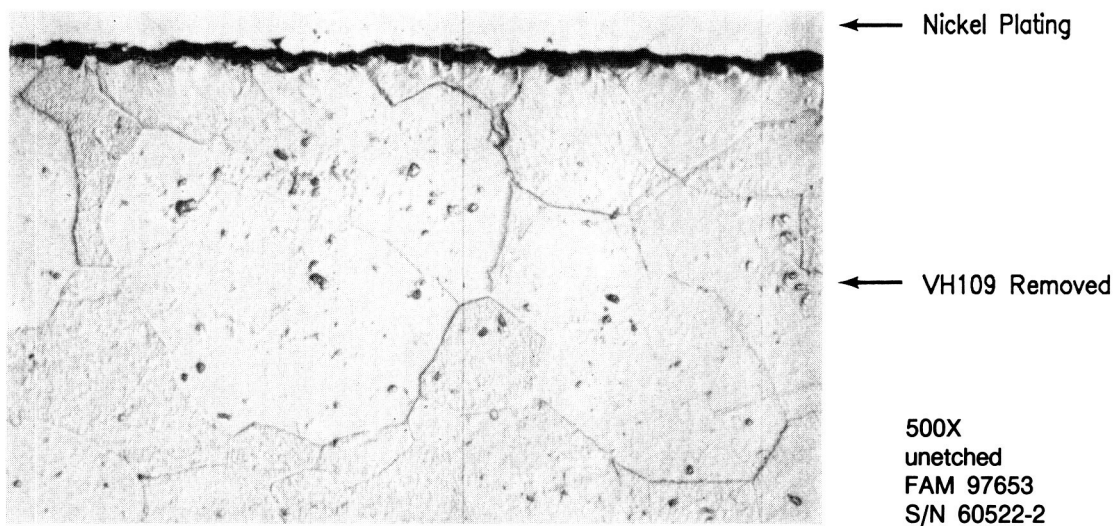
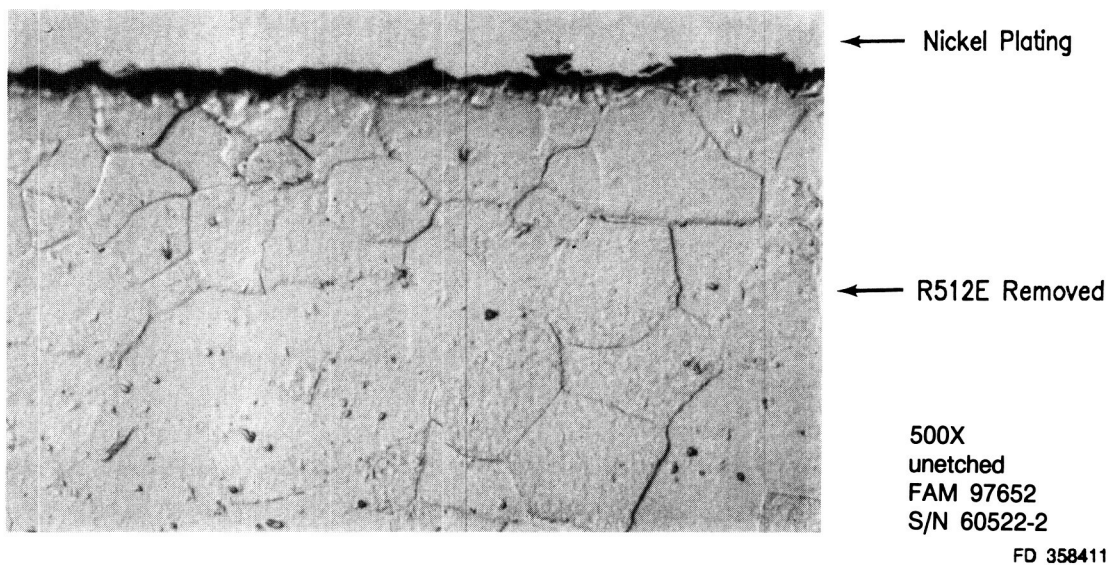
*Figure 4-1. Cross Sections After Grit Blasting to Remove Surface Oxides and Coating*

A lengthwise narrow strip of material was removed from the center of the flame pattern of each panel. The strips were grit blasted to remove all coating and surface oxides. This procedure produced a sample that was essentially substrate with no coating (Figure 4-1). Five equally spaced locations were then removed from each panel (Figure 4-2) and tested by a Leco Gas Analyzer.

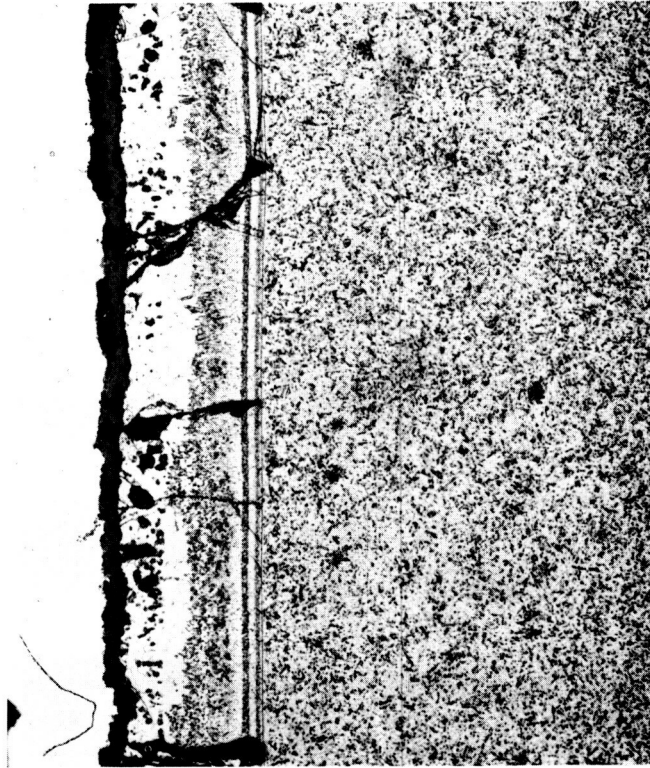
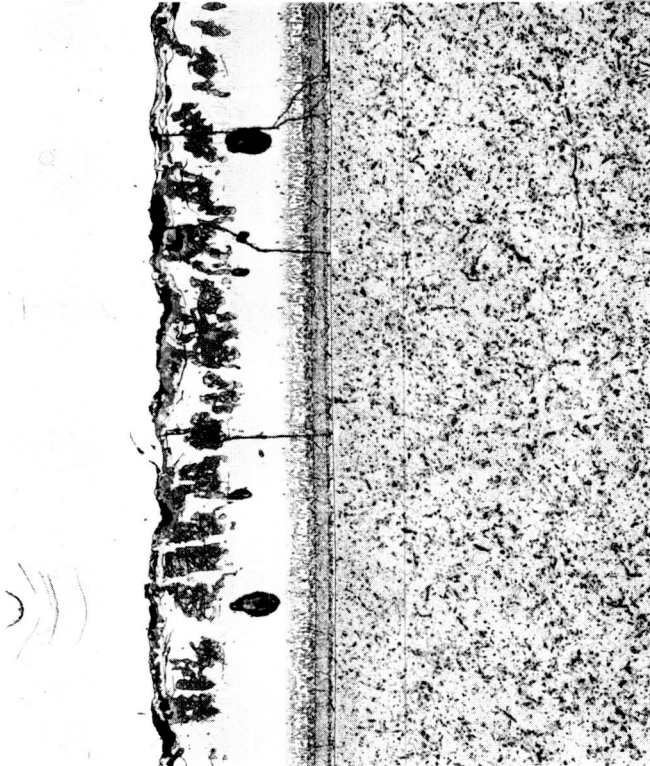
*Figure 4-5. Equivalent Flame-Side Microstructures of R512-E and VH-109 After Engine Exposure — Run Time: 4451 seconds — Start/Stop Cycles: 23*

Figure 4-5 compares typical microstructures of engine tested R512-E and VH-109. Figures 4-6 and 4-7 compare the as-received and engine tested coatings of R512-E and VH-109 respectively. Microstructural degradation of either coating was minimal. Subtle microstructural changes were more prevalent in the VH-109 coating (second phase instability and increased near surface porosity) than the R512-E coating (elemental partitioning). The protective nature of each coating is illustrated by microhardness measurements (Table 4-2). Aside from coating affected data points, no locations were significantly embrittled by engine exposure.

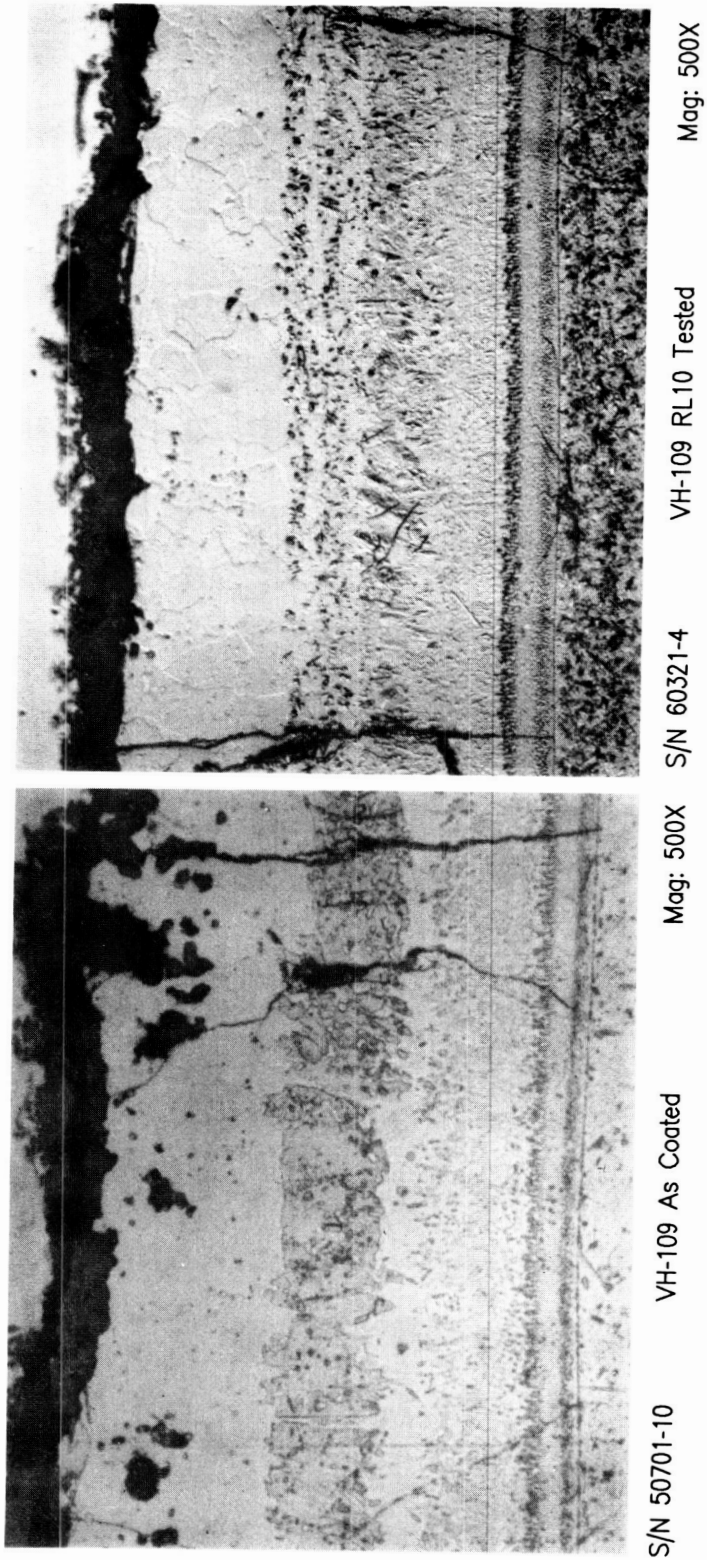
*Figure 4-7. Pretest and Post Test Flame-Side Microstructures of VH-109*

Reduced substrate cross-sectional thickness was the primary difference between the performance of the coatings (Table 4-3). The observation that additional substrate may have been consumed by the VH-109 coating and the redistribution of secondary phases indicates that VH-109 may not be totally stable in this temperature range. The panel thickness varied from 13.5 mils at the inlet and exit planes to 10.1 mils at the panel center. The R512-E panel thickness was relatively constant at 13.3 mils. Data presented by Battelle, Columbus as part of this nozzle study concurred with the greater thickness predictability of the R512-E over the VH-109 (Figure 5-1<sup>6</sup>). The predictability of the coating/substrate system interaction is critical. An unexpected deviation in the load-bearing cross-sectional area of the nozzle could result in an overload condition.

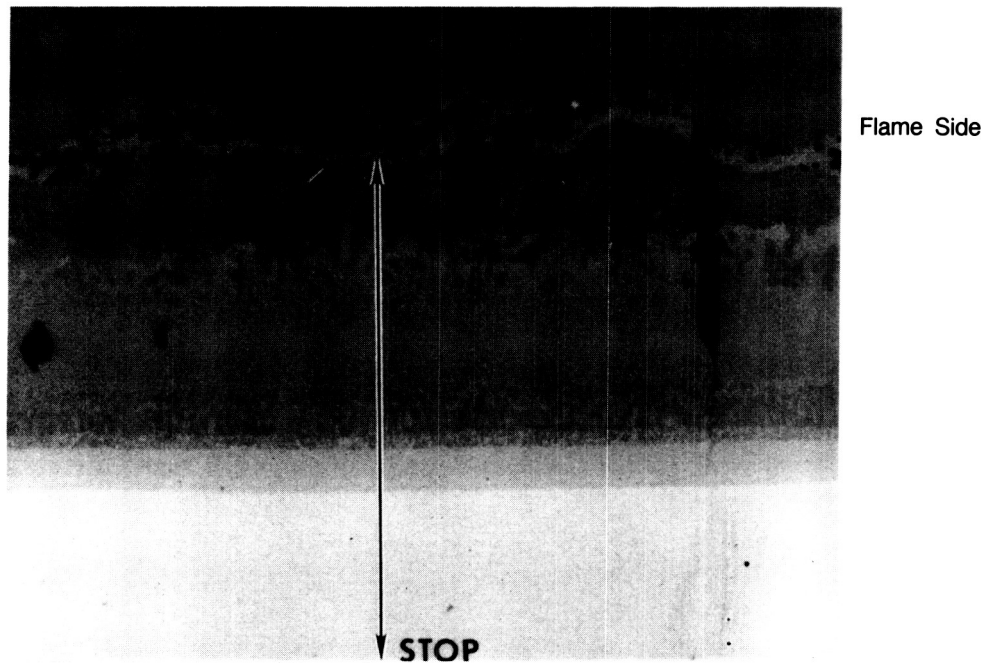
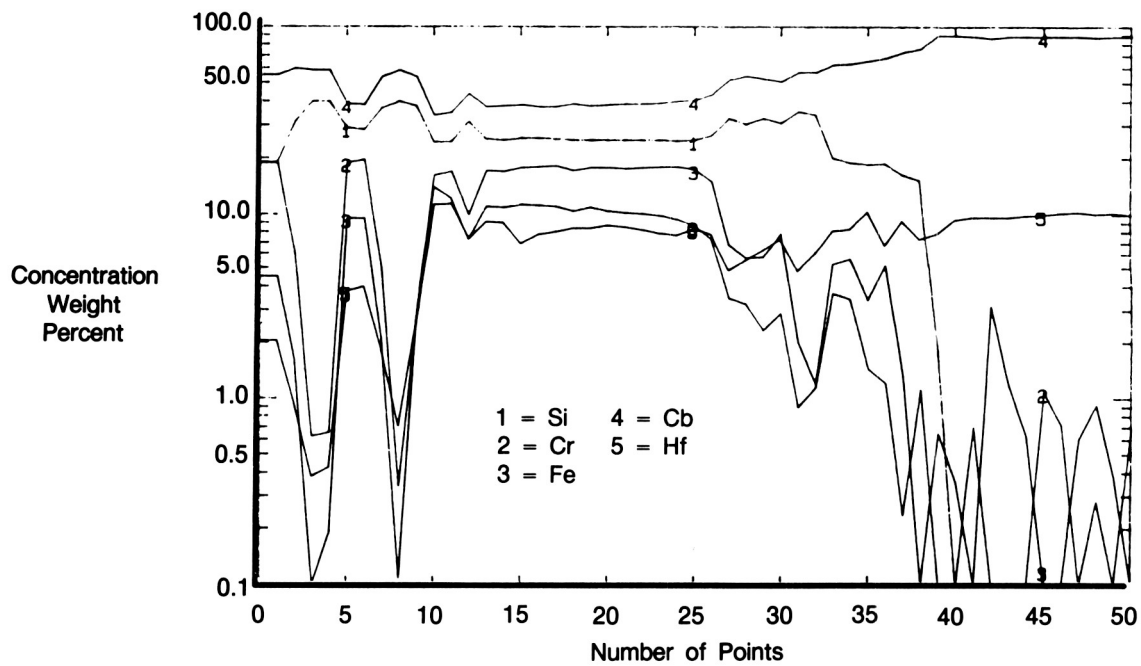
Figure 4-8. As-Coated R512-E Composition Profile

Figures 4-8 and 4-9, and 4-10 and 4-11 illustrate the composition profiles of R512-E and VH-109 before and after testing, respectively. The R512-E microstructural features shown in the backscattered electron images indicate no change due to the engine exposure. The concentration profiles show activity at the coating surface. Initially, high concentrations of Cb and Si were present at the coating surface. After engine testing, depletion of Cb and Si and an enrichment of Cr and Fe occurs in the near-surface coating. This type of compositional change would be expected due to the formation of Cb/Si oxide scales. Examination of the VH-109 coating showed significant change in the microstructural distribution of secondary phases. The presence of large intermittent Cr/Hf phases was altered to form a continuous population of fine precipitates. Figure 4-10 shows the trace of the profile as it passes through a large second-phase region and the associated Cr and Hf enrichment. Figure 4-11 shows the trace initially encountering a zone of similar compositional characteristics, but the zone is short-lived as it breaks down into the compositional peaks of smaller, finely dispersed precipitates. Near-surface elemental depletion/enrichment associated with oxide formation, occurred in a manner similar to the R512-E coating.
